VISUAL IMPACT REPORT

Lafarge Canada Inc. – Proposed Pit 3 Extension

Part of Lot 13, Concession 5 WHS Town of Caledon, Region of Peel

February 2024

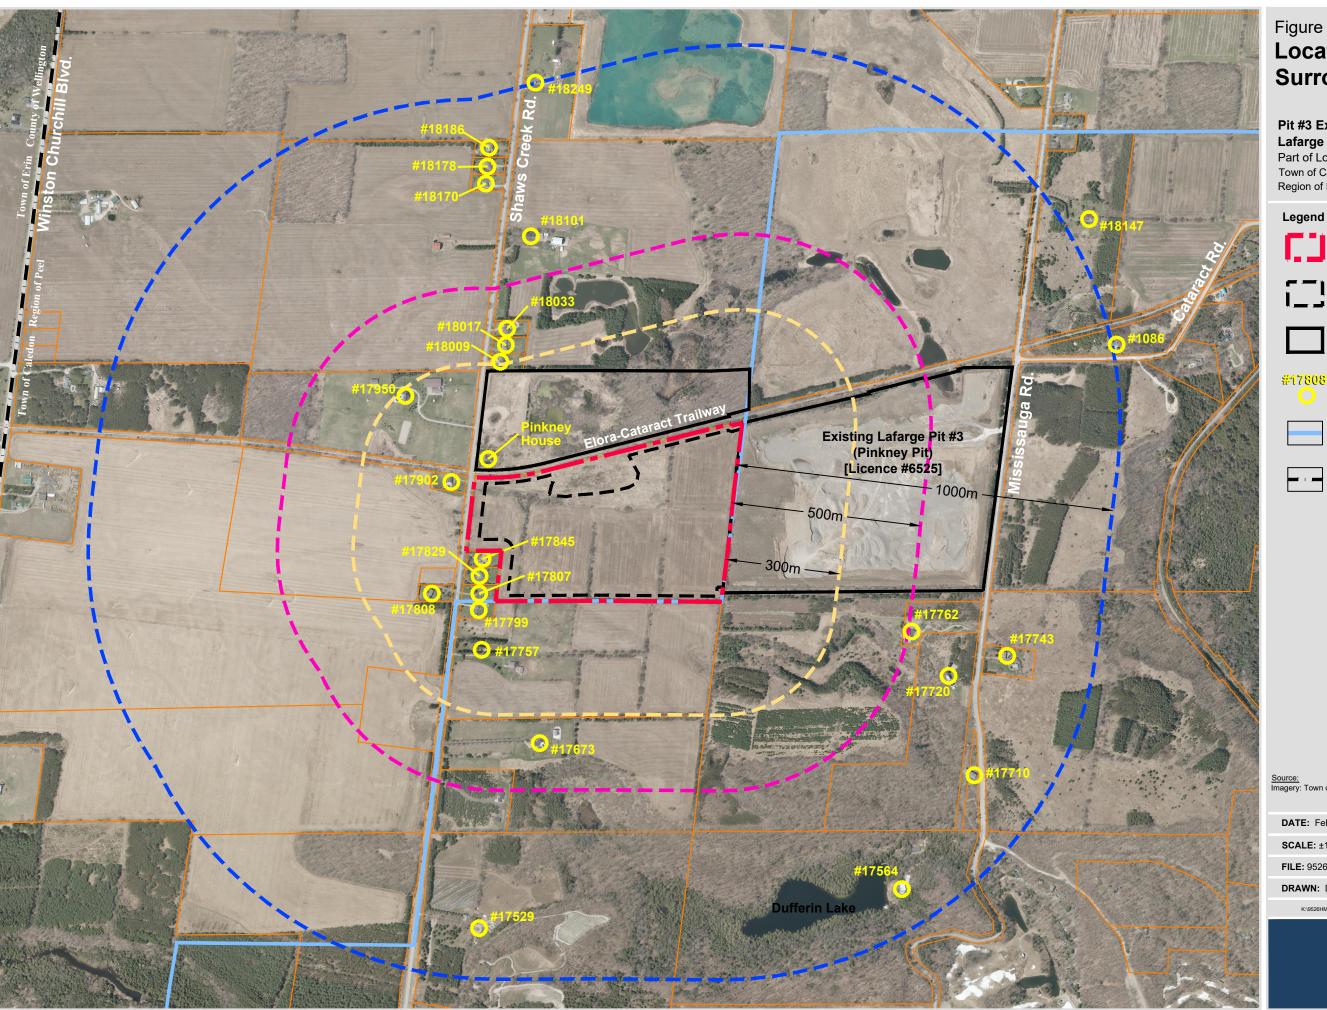
Figure 2

Location of **Surrounding Receptors**

The subject lands are adjacent to the existing Lafarge Pit #3 (License #6525) owned by Lafarge Canada Inc, which can be accessed from Mississauga Road. There are several residences primarily on the east side of Shaws Creek Road as well as a few located to the west side, south and north of the Elora-Cataract Trailway. **Figures 2 & 3** provide an overall view of the site context.

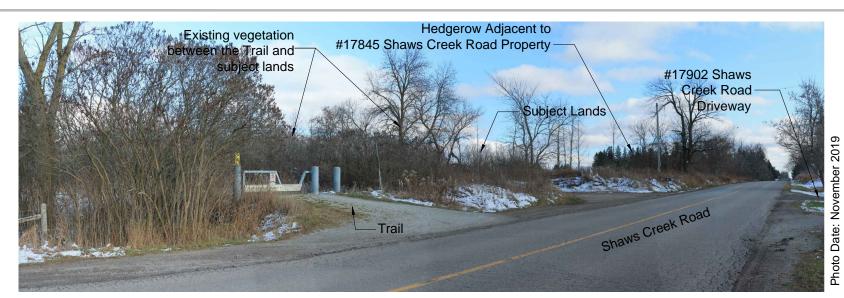
Photo 1: View from 17950 Shaws Creek Road looking southeast towards northwest corner of the site. Views into the site are partially screened by existing vegetation and topography.

Table 1.	Summary of V	isual Impa	cts	
Viewshed/ Photo	Description of View	Value	Potential Impact (without mitigation)	Recommended Mitigation (Figure 10)
Figure 8A	& 8B: Shaws C	Creek Road	- Viewsheds	
Photo 1	17950 Shaws Creek Road	Moderate to High	High Existing vegetation partially screens current view and is to remain for the duration of operations of the site. Existing topography allows for framed open views into the site.	Provide a berm at 403masl along Shaws Creek Road and a berm at 401masl along the Trail and tree screening within setback.
Photo 4	17799 Shaws Creek Road	High	High Existing topography and existing vegetation allows for partially unobstructed views of the site from the rear of the residence.	Provide a berm along a portion of the southern boundary of the site at 401masl and provide tree screening within setback along the foot of proposed berm as well as additional planting towards the southeast corner to supplement the existing hedgerow to remain where no berm is required.

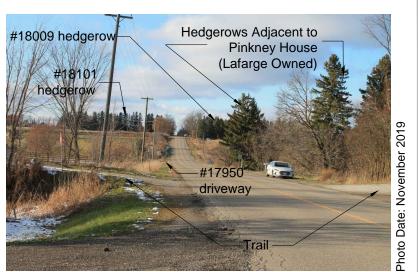
Photo 2: View from 17902 Shaws Creek Road looking north towards 18009 Residence. Views into the site are partially screened by existing vegetation.

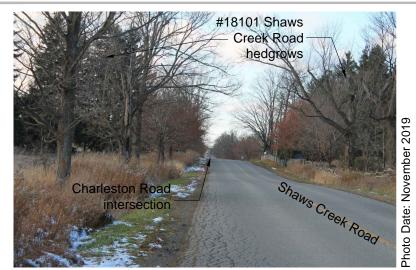
Photo 3: View towards 18101 Shaws Creek Road looking north towards Charleston Sideroad. Views into the site are screened by existing vegetation, topography and distance.

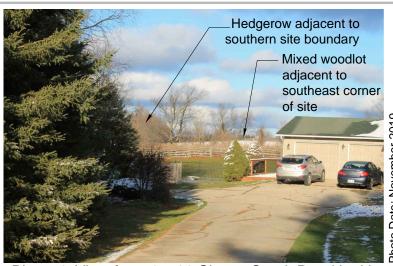
Photo 4: View from 17799 Shaws Creek Road looking along the southern edge of the site. Views into the site are partially screened and filtered by existing vegetation and topography.

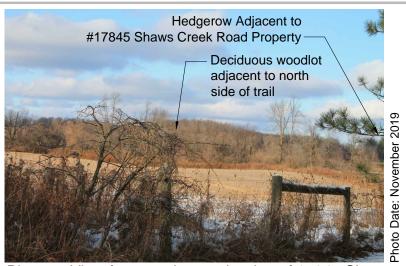
Photo 5: View from road at north edge of 17845 Shaws Creek Road property, looking northeast into the site. Views into the site are partially open with some framed and filtered views by existing vegetation and topography.

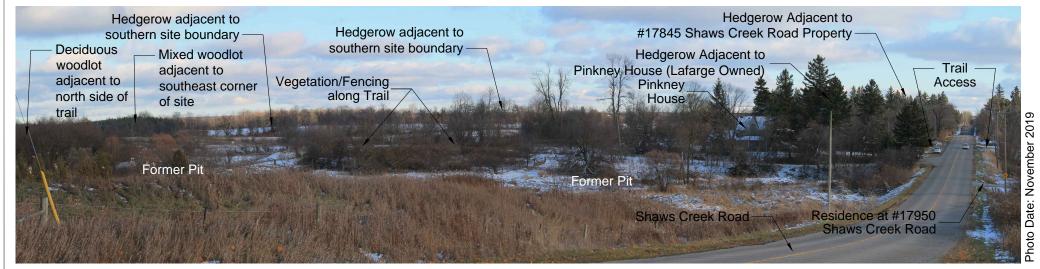
Photo 6: View from 18009 Shaws Creek Road looking southeast toward the site. There are some partially framed and filtered views into the site from some residences and Shaws Creek Road due to topography and openings in existing vegetation along the Trail.

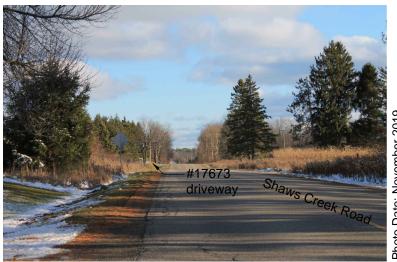
Photo 7: View towards 17673 and 17529 Shaws Creek Road, along road. Road slopes down toward river and Bush Street. No views of site due to existing topography and vegetation.

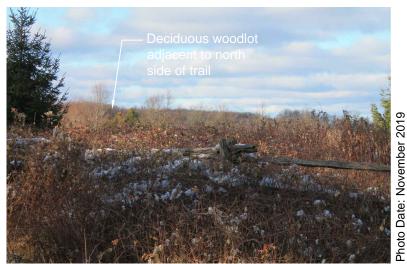
Photo 8: View looking towards the site from Shaws Creek Road, along road. Views of site are partially screened due to existing topography and vegetation.

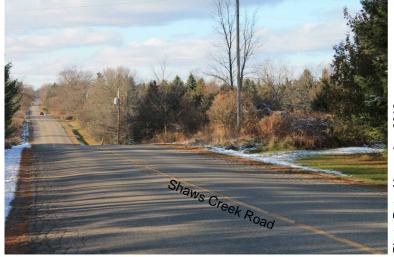
Photo 9: View looking northeast towards the site from Shaws Creek Road. Views of site from the road are well screened due to existing topography and vegetation.

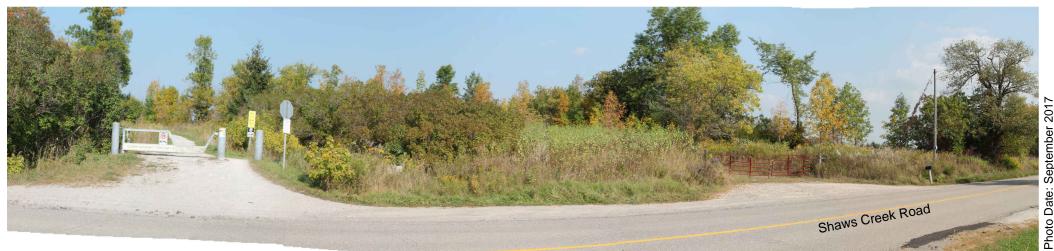
Photo 10: View looking towards the northwest corner of the site and Elora-Cataract Trail entrance from Shaws Creek Road. Views of site from the road are well screened due to existing topography and leaf on vegetation.

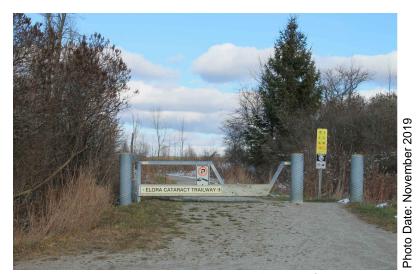
Photo 11: View towards entrance of Elora-Cataract Trail from Shaws Creek Road. Framed partial views into site due to existing topography and existing vegetation.

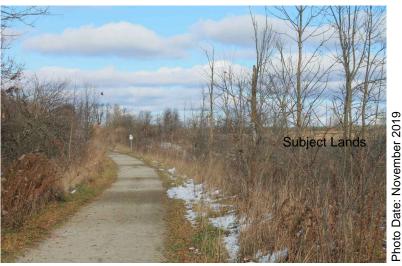
Photo 12: View along trail looking toward site. There are filtered partial views into site due to existing vegetation along south side of trail.

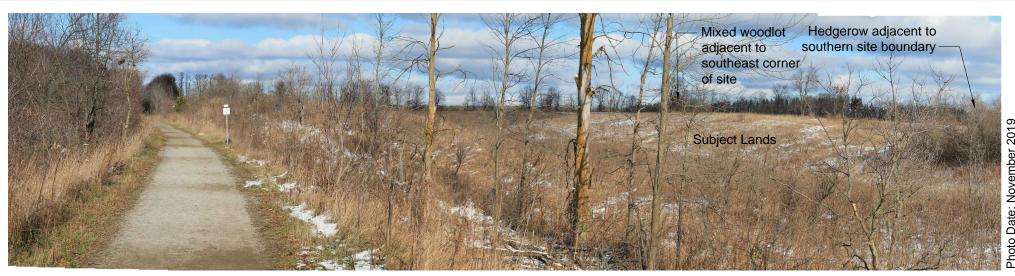
Photo 13: View further along trail looking toward site. There are generally open views into site due to lack of existing vegetation along south side of trail at this location.

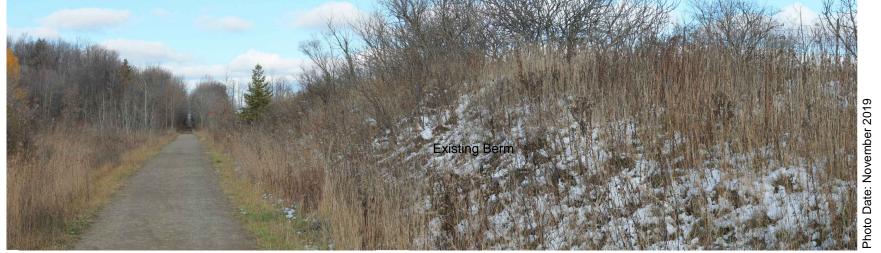
Photo 14: View further along trail looking toward site. There are no views into site due to existing berm and existing vegetation along south side of trail at this location.

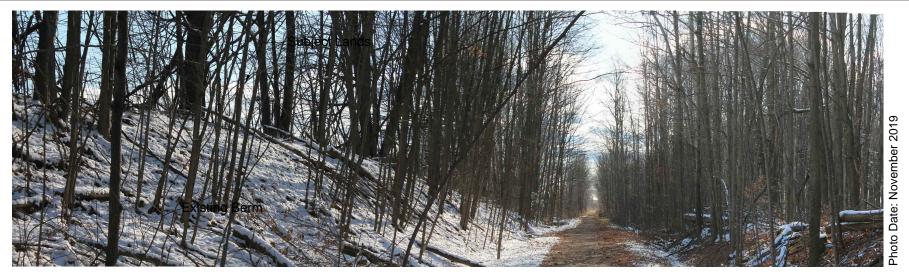
Photo 15: View at northeast corner of site from the trail looking southwest toward site. There are no views into site due to existing topography and existing vegetation along south side of trail at this location.

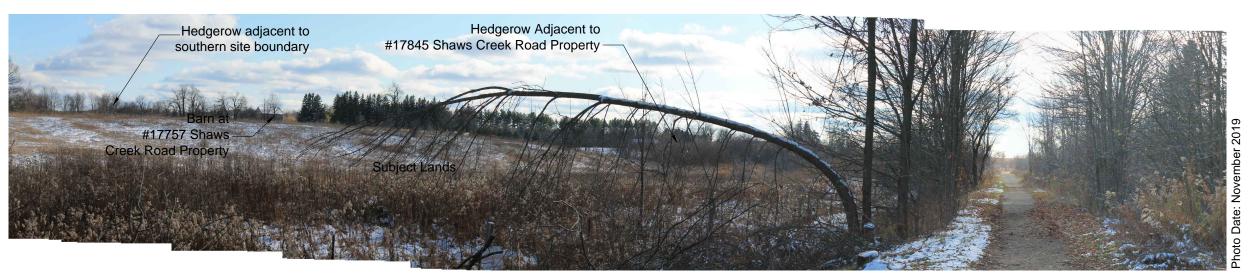
Photo 16: View along trail looking southwest toward site. There are open framed views into site due to existing topography and lack of existing vegetation along south side of trail at this location.

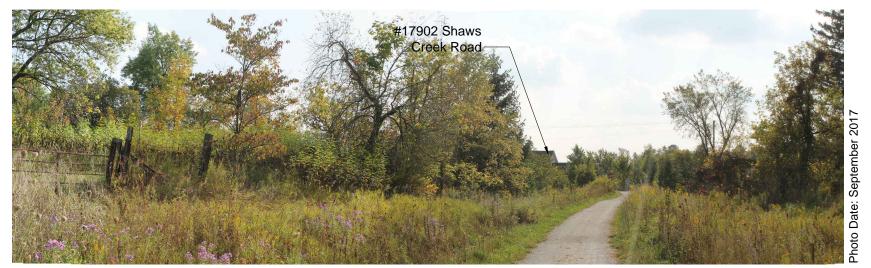
Photo 17: View along trail looking towards northwest corner of site and trail access from Shaws Creek Road. There are no views into site due to existing topography and existing vegetation in leaf on condition along south side of trail.

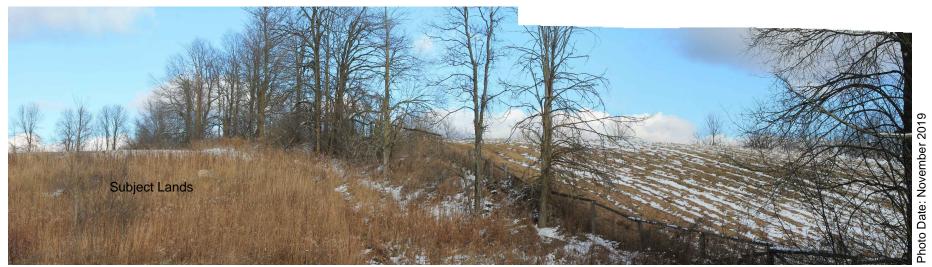
Photo 20: View looking southeast towards existing hedgerow located along the southern site boundary. There are limited potential views into the site from receptors to the south due to existing topography and existing vegetation. There are no views from Shaws Creek Road.

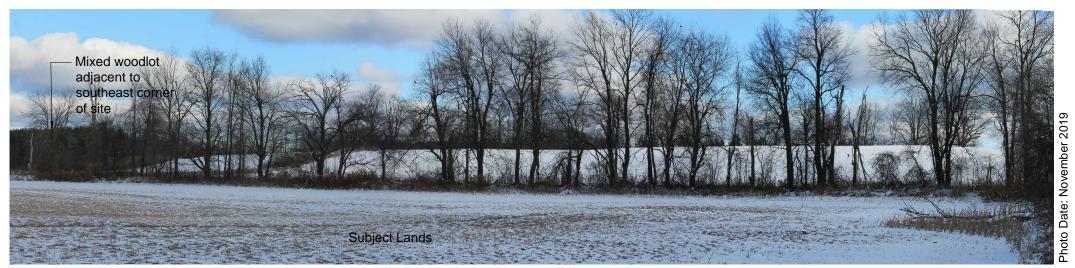
Photo 21: View looking south towards existing hedgerow located along the southern site boundary. Views into the site from receptors to the southwest are limited due to existing topography and existing vegetation.

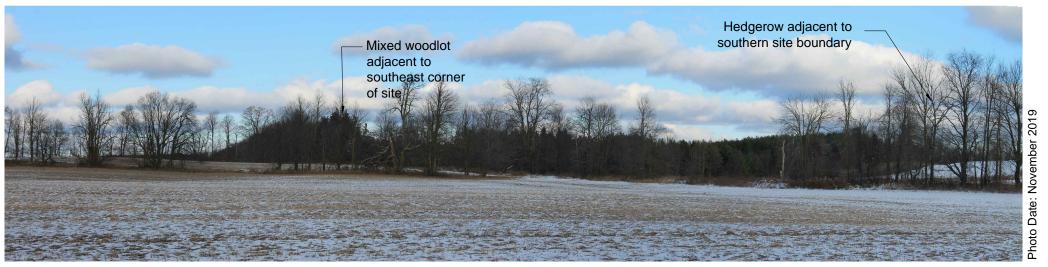
Photo 22: View looking southeast towards existing woodlot adjacent to the southeast corner of the site boundary. Views into the site from receptors to the southeast are screened due to existing topography and existing vegetation.

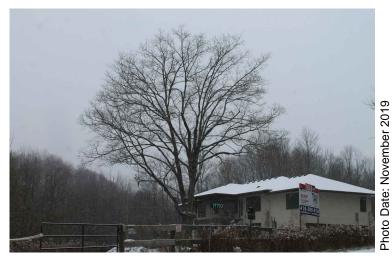
Photo 23: View looking west towards the site from 17710 Mississauga Road. Views are screened by existing woodlots and topography.

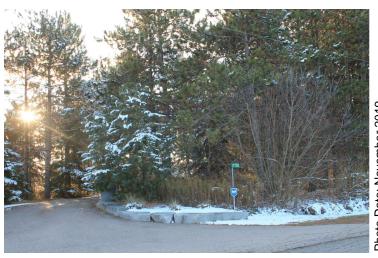
Photo 24: View looking west towards the site from 17720 Mississauga Road. Views are screened by existing woodlots, vegetation and topography.

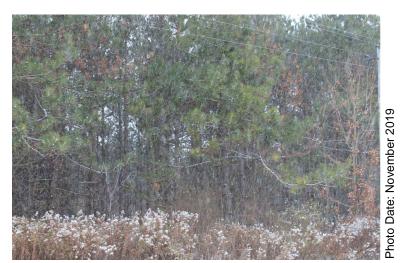
Photo 25: View looking west towards the site from 17743 Mississauga Road. Views are well screened by existing hedgerow along Mississauga Road.

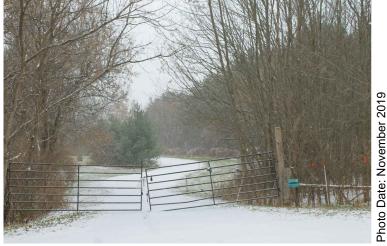
Photo 26: View looking west towards the site from 17762 Mississauga Road. Views appear to be well screened by existing woodlots and vegetation to the northwest and west of the property.

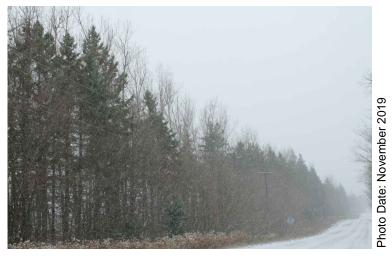
Photo 27: View looking northwest along Mississauga Road from 17762 Mississauga Road. Views towards the site are well screened by the existing hedgerow along frontage of Existing Pit #3.

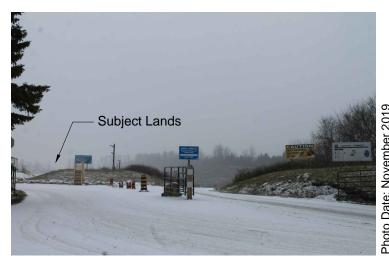
Photo 28: View looking west towards site from the site entrance to Existing Pit #3. Views are generally filtered or screened from Mississauga Road by existing woodlots, hedgerow and distance.

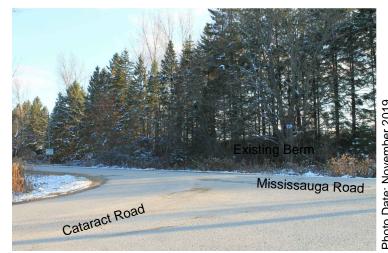
Photo 29: View from intersection of Mississauga and Cataract Roads, looking southwest towards site. Views are screened by existing hedgerow and berm.

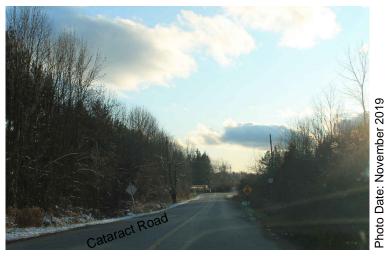
Photo 30: View from 1086 Cataract Road, looking southwest towards site. Views are screened by existing woodlots, hedgerows and distance.

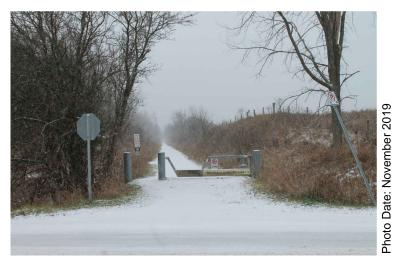
Photo 31: View of Elora-Cataract Trail access from Mississauga Road looking southwest along trail. Views are screened by existing vegetation and distance.

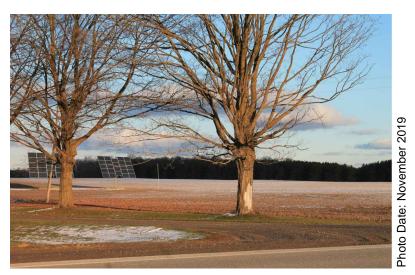
Photo 32: View from 18133 Winston Churchill Boulevard looking east towards site. Views are well screened by existing vegetation and distance.

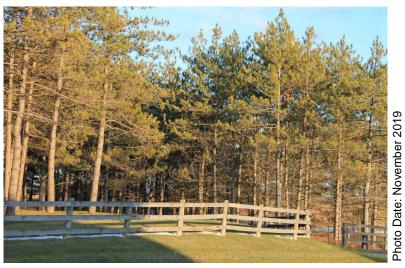
Photo 33: View from intersection of Side Road 15 and Winston Churchill Boulevard looking east toward site. Views are well screened by existing vegetation and distance.

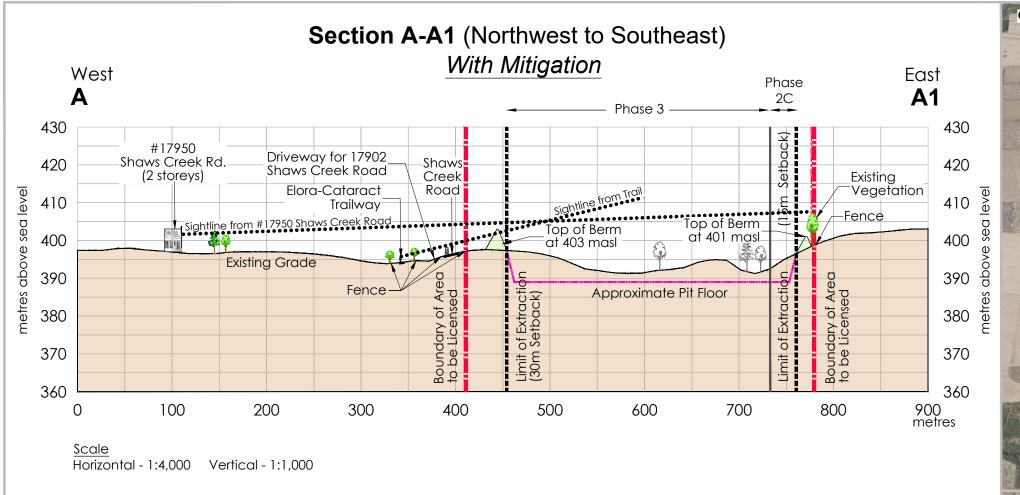
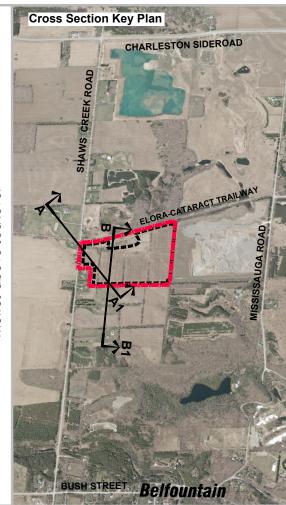
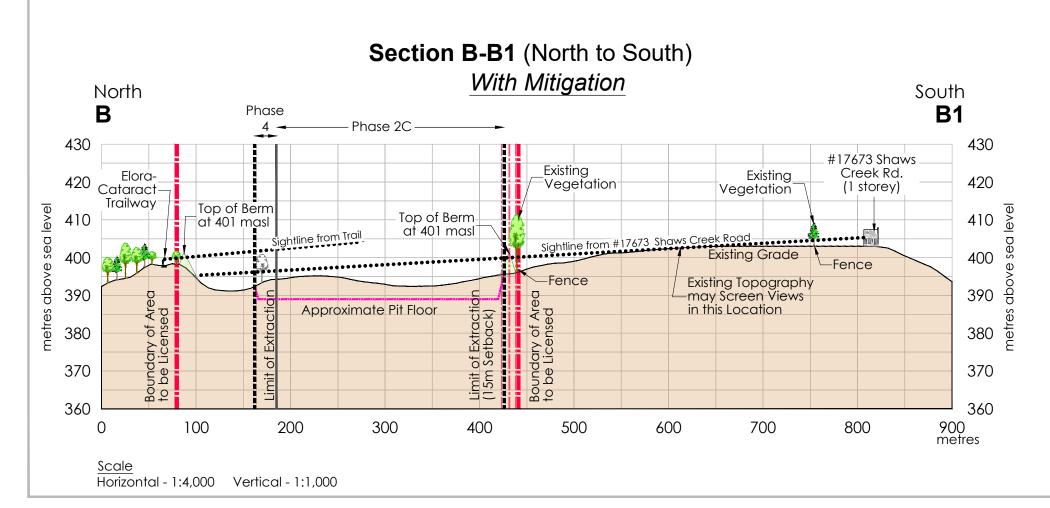
Figure 9A

Cross Sections A and B

Cross-sections are included in **Figures 9A to 9C** which illustrate the views relative to the subject lands. The phases of the proposed pit including the stockpiling area are identified on the cross-sections and Operational Plan **(Figure 5)**. The views take into account the proposed mitigation outlined in the preceding chart.

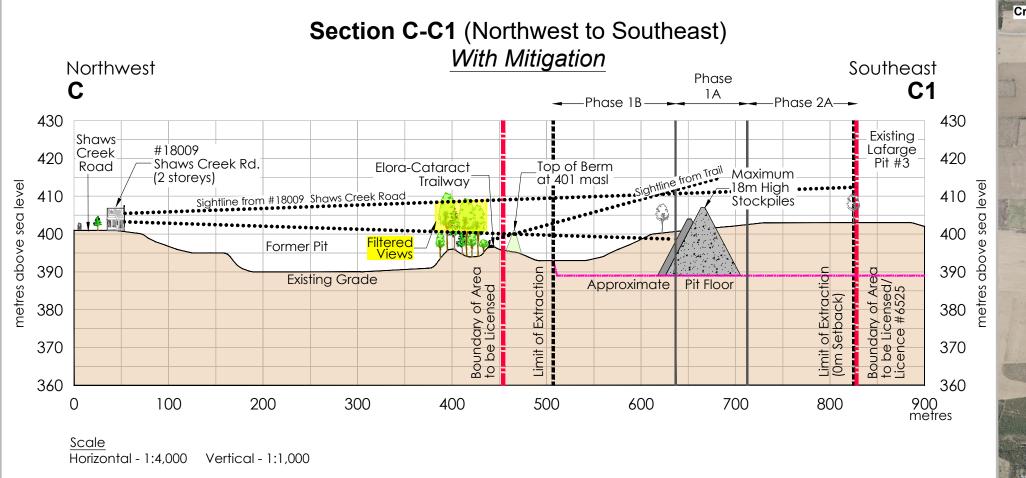
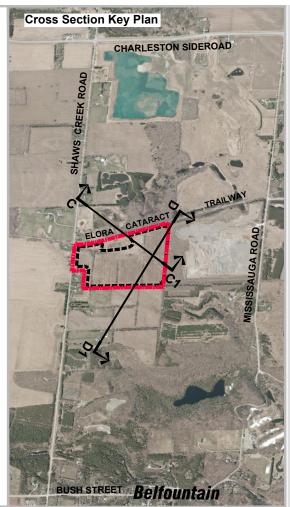
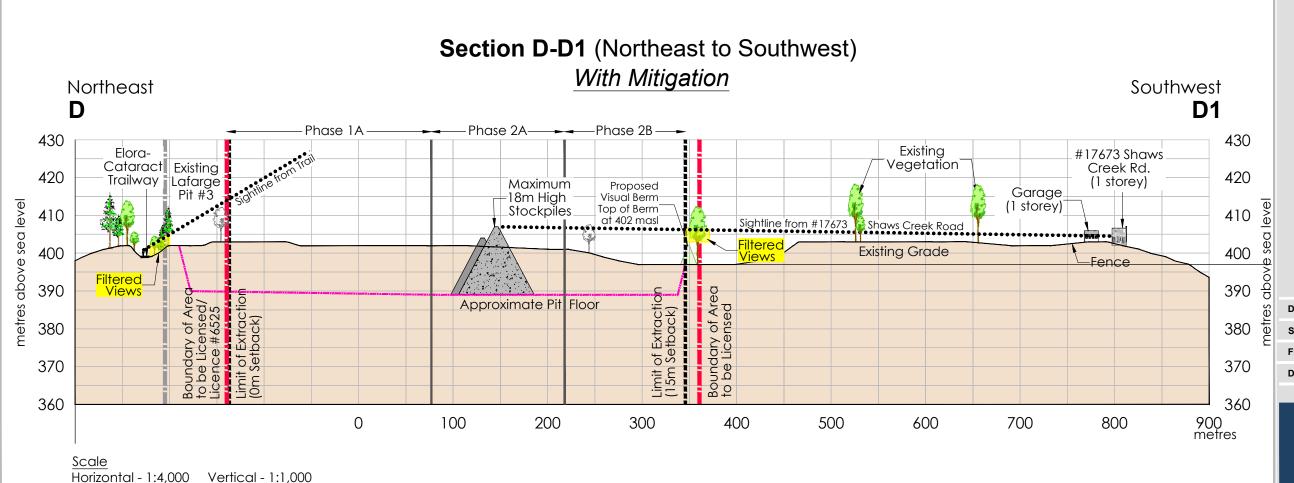
Figure 9B

Cross Sections C and D

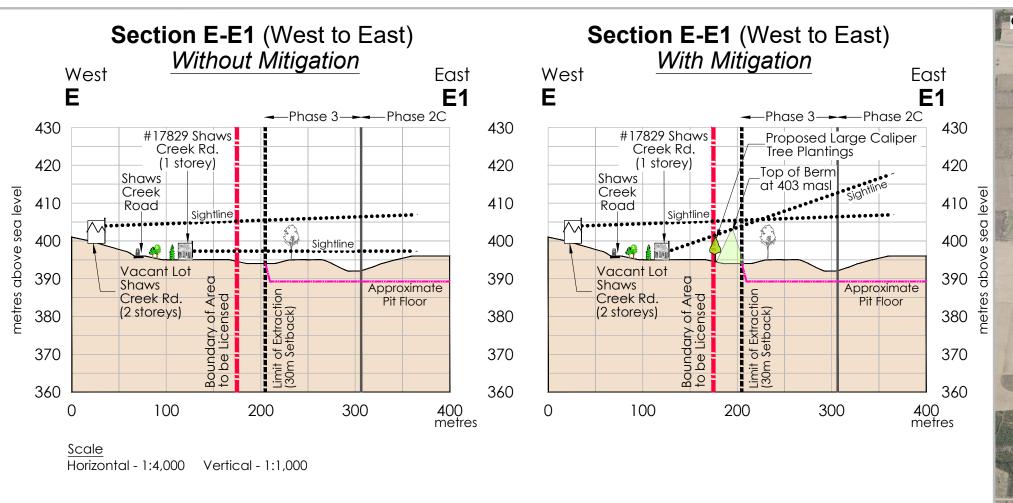
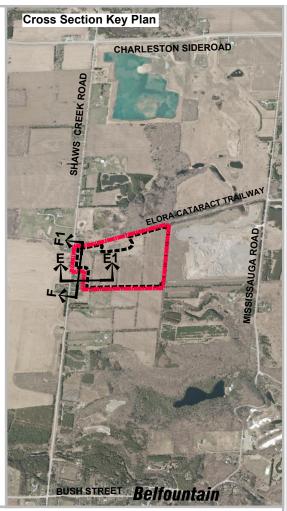
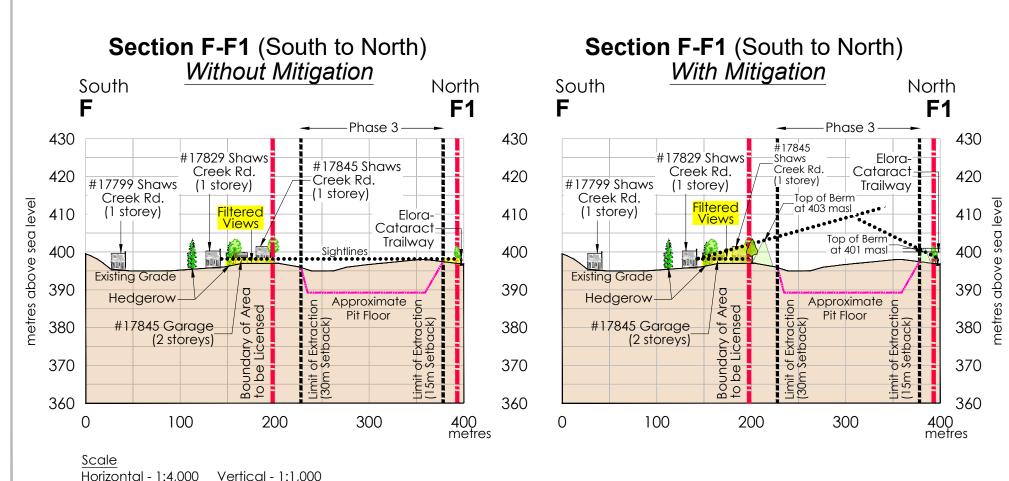
Figure 9C

Cross Sections E and F
