# Project Spotlight

Dawson Road Office Parking Lot

## Lafarge's UltraSeries™ FiberPlus Steel replaces rebar in concrete paving.

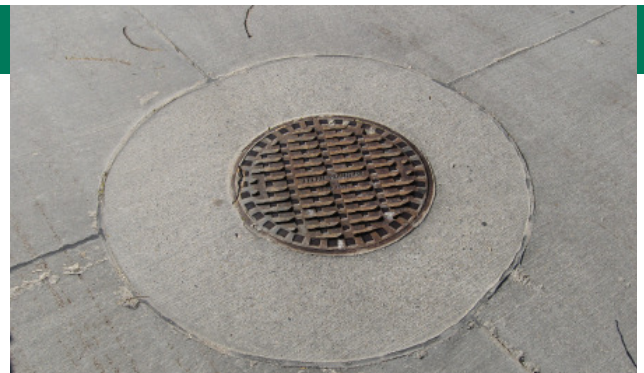
This image shows a close up of Lafarge's Winnipeg office parking lot. The top half of the image shows the side reinforced with UltraSeries™ FiberPlus Steel, and the bottom half shows the side reinforced with rebar.

To test the performance of both UltraSeries™ FiberPlus Steel and conventional rebar, half of the parking area was paved using conventional rebar as primary reinforcement while the other half was paved using UltraSeries™ FiberPlus Steel. The parking lot in front of Lafarge's Dawson Road office has been in service for over 10 years with both halves effectively withstanding Winnipeg's harsh winter climate. To date, neither half of the Dawson Road office parking lot has required any maintenance. This means that the long-term performance of both conventional rebar and UltraSeries™ FiberPlus Steel are comparable. The difference between these two forms of reinforcement lies in the ease of placement at installation.

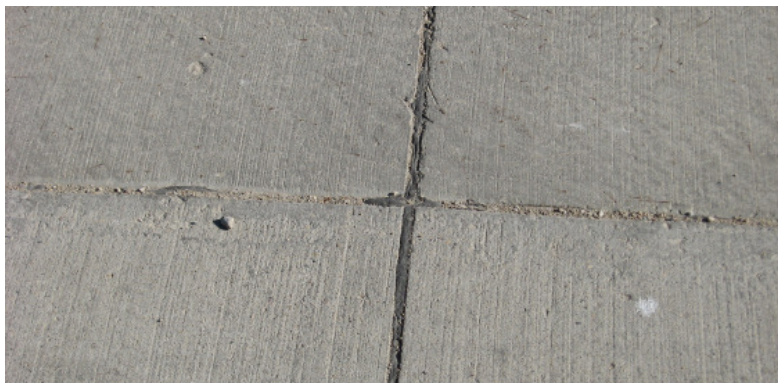
After being in service for over 10 years, both halves of the parking lot in front of Lafarge's Winnipeg office exhibit minimal cracking and wear and tear.
